ODI RESUME

Investigation: PE 13-010

Subject: Rear suspension knuckle fracture

Products: Model Year 2003 - 2010 Dodge Viper

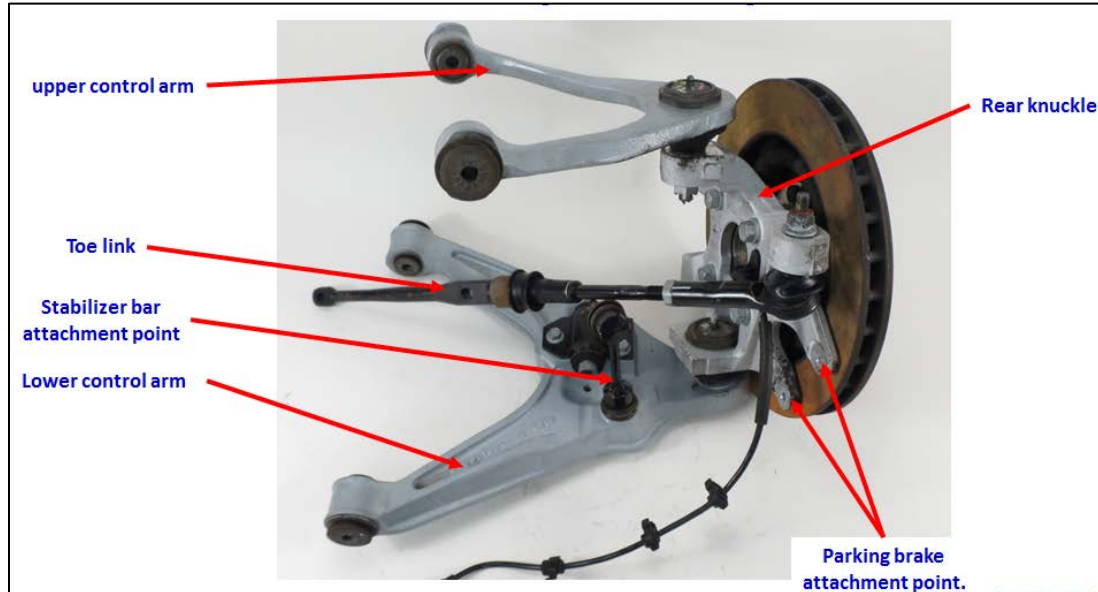
Figure 1. Right rear knuckle viewed from rear.

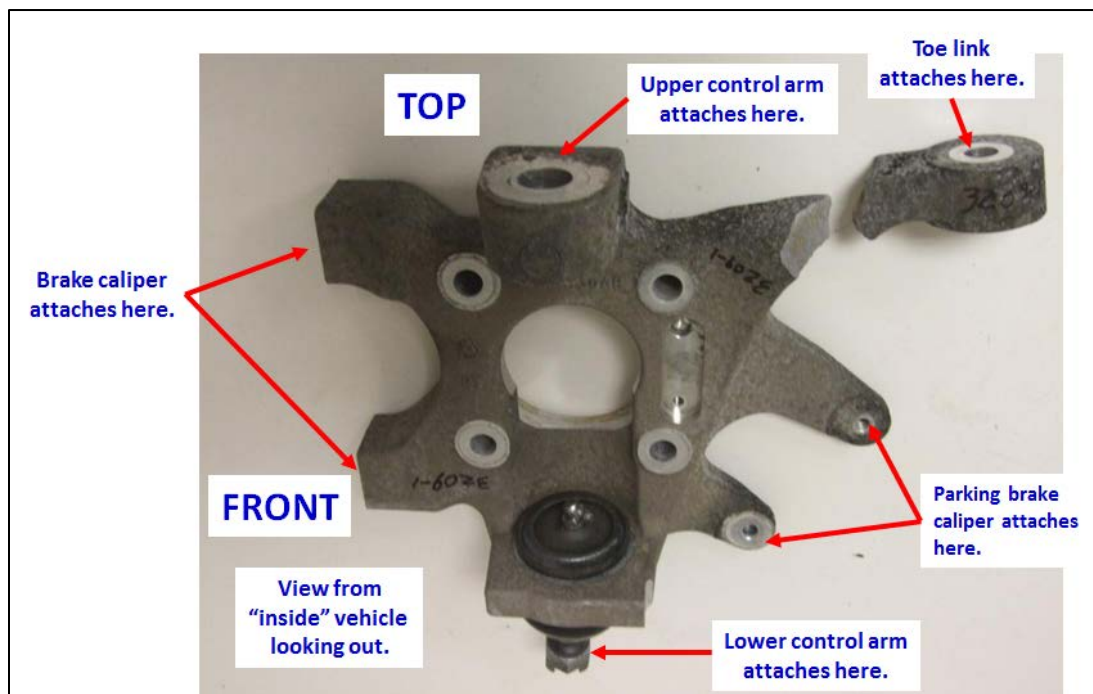
(Figures 2-4) and some in compression (Figures 5-6). Seven of the 8 incidents in which the side of the knuckle failure was identified involved right knuckles, the side that is generally most common for impact failures involving wheel and suspension components. The single, left side failure was associated with an incident involving an impact with a concrete barrier dividing highway travel lanes. Analysis of the failure data indicated these are random events and do not show any clear patterns related to vehicle build range, vehicle age or mileage.

Figure 2. Right rear knuckle with fractured toe link attachment arm.

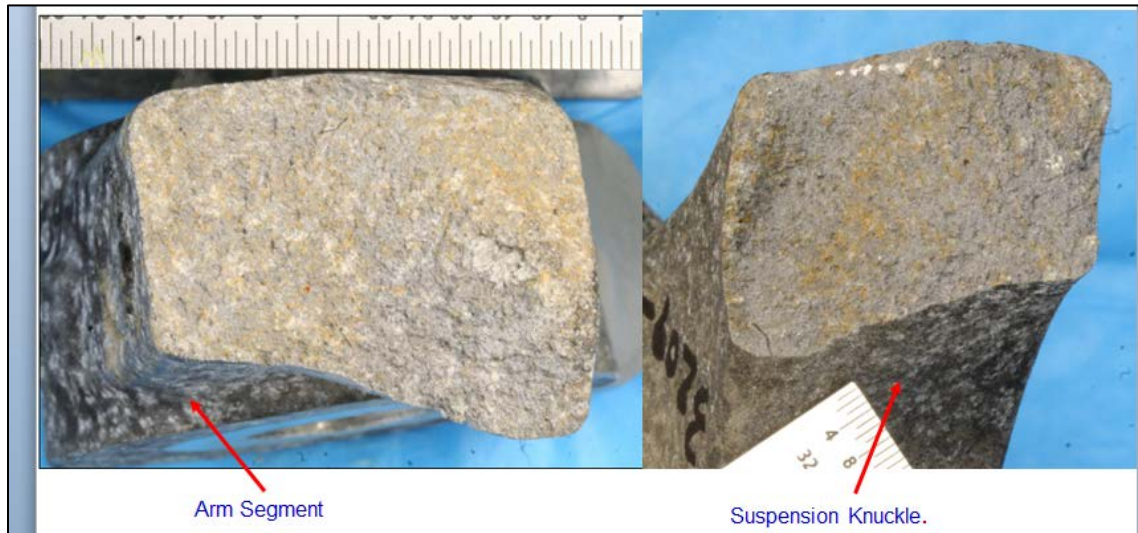
Figure 3. Fracture surface, rear knuckle toe link attachment arm (VOQ 10510248).

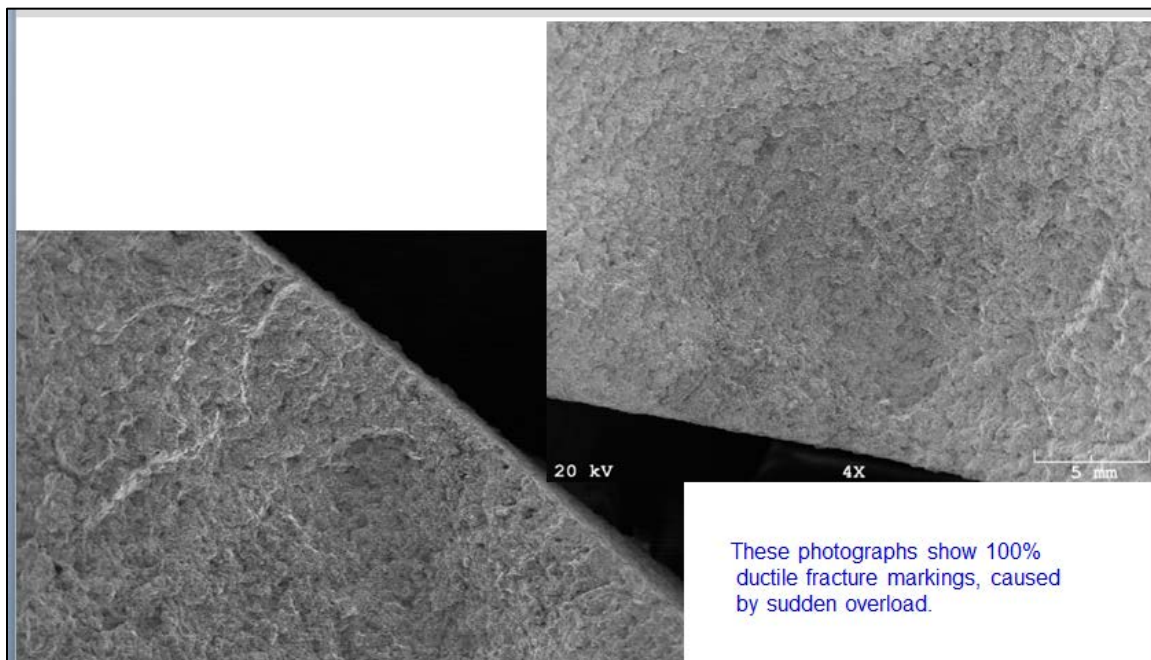
Figure 4. Low magnification Scanning Electron Microscope fracture surface images (VOQ 10510248).

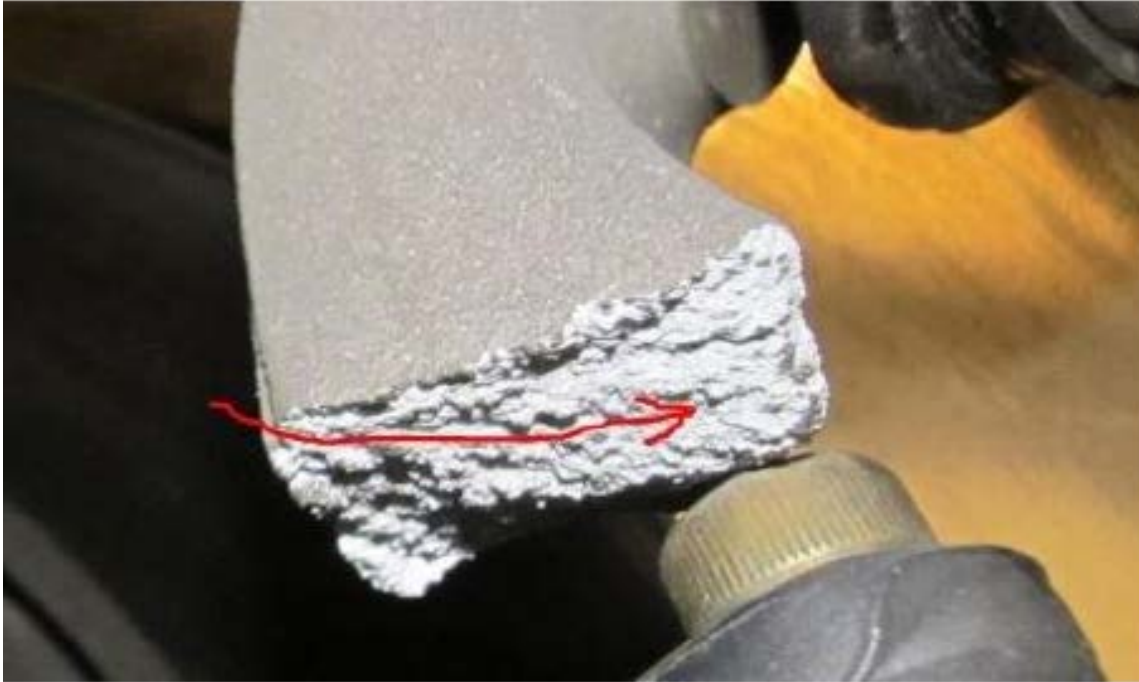
Figure 5. Estimated crack initiation point and propagation direction

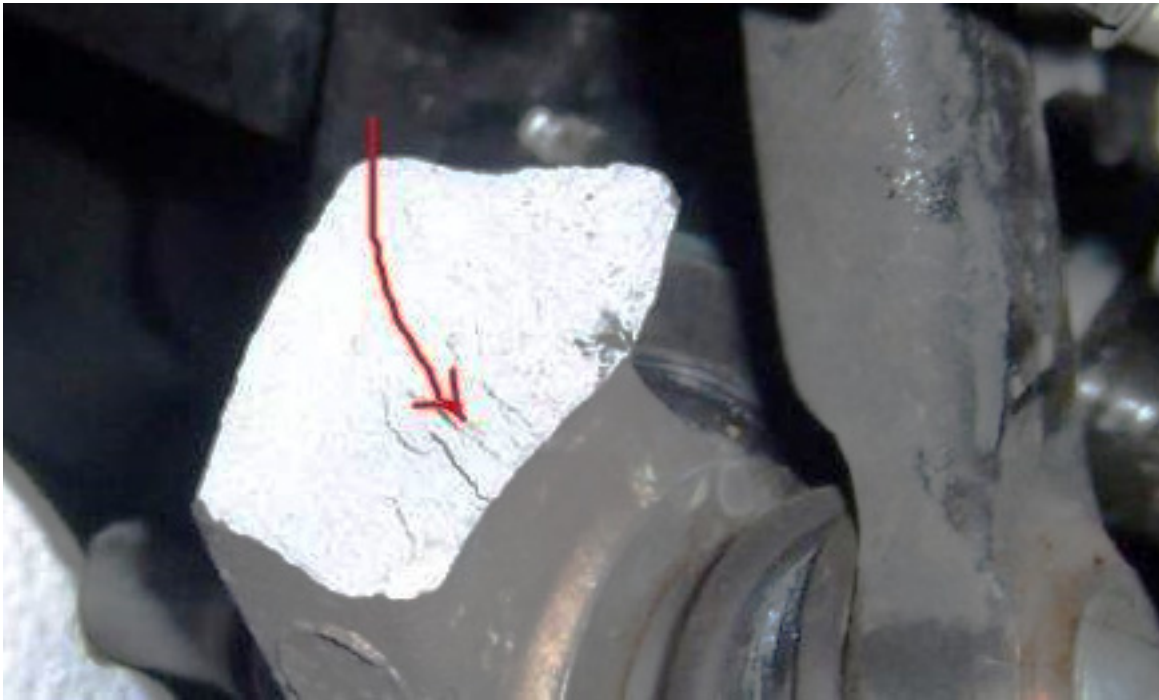
Figure 6. Estimated crack initiation point and propagation direction
